Geospatial Aspects of Emergency Response

Oroville Dam Spillway

September 6, 2017 NGAC

Oroville Dam Background Info

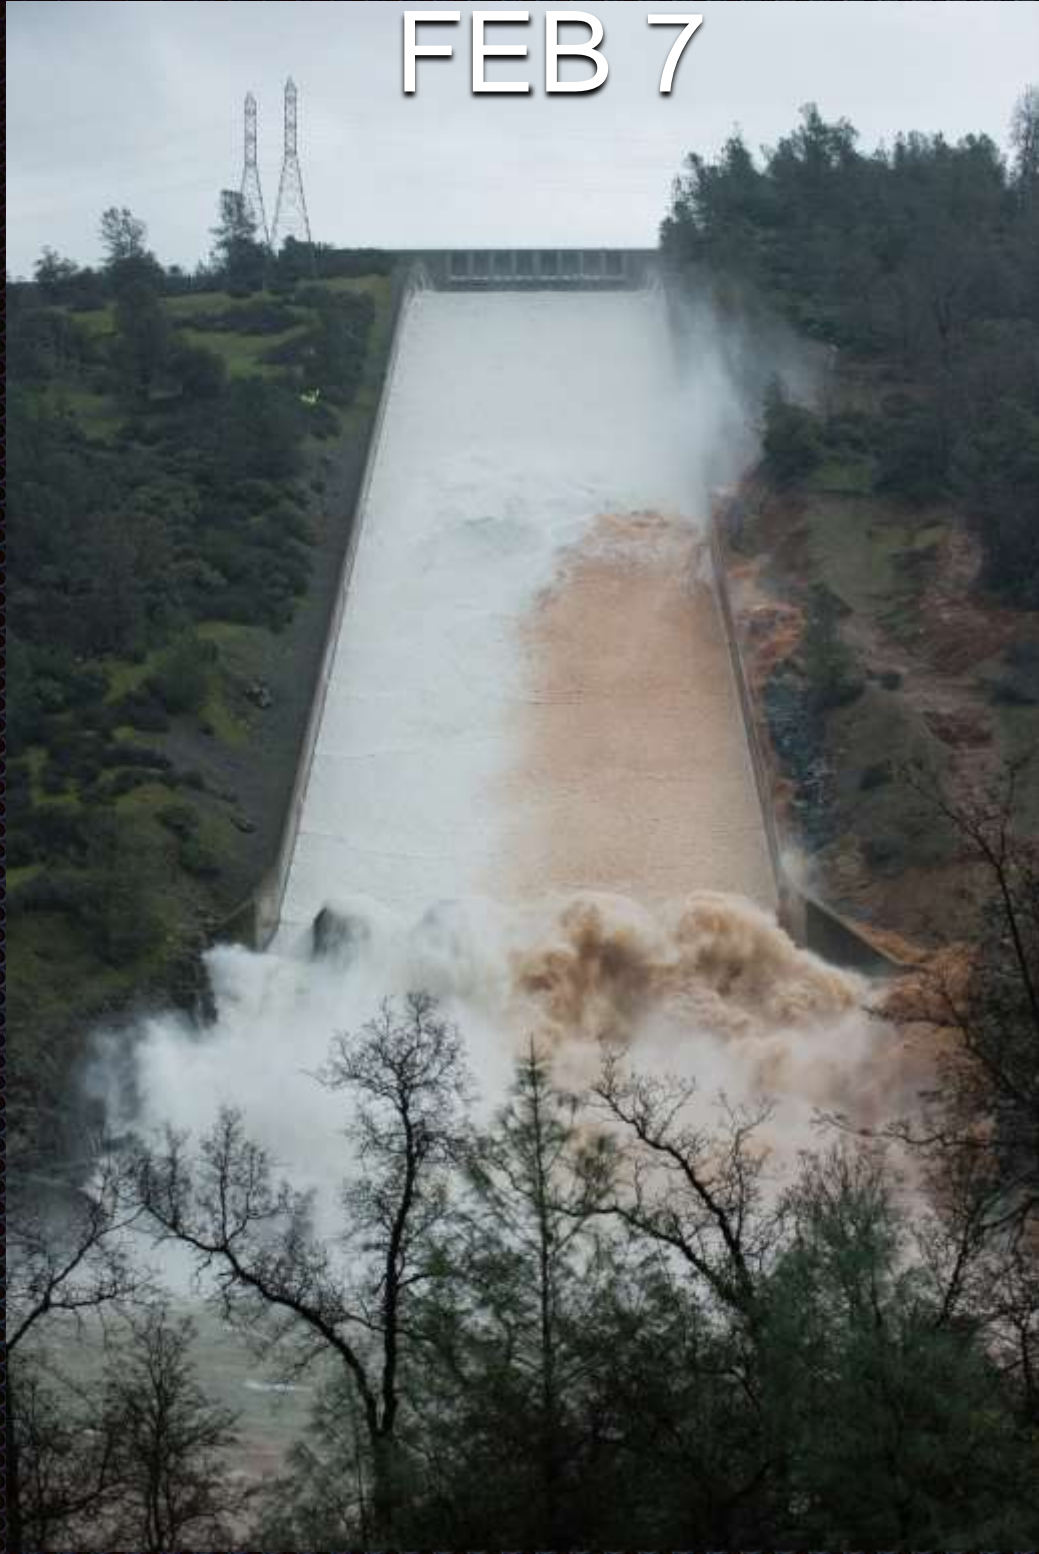
FEB 7

① February 7: As water releases from the flood control spillway ramp up to 54,500 cubic feet per second (cfs), in anticipation of inflows expected from rainfall, DWR employees notice an unusual flow pattern. Spillway flows stop for investigation. Engineers find large area of concrete erosion.

Damage to Main Spillway

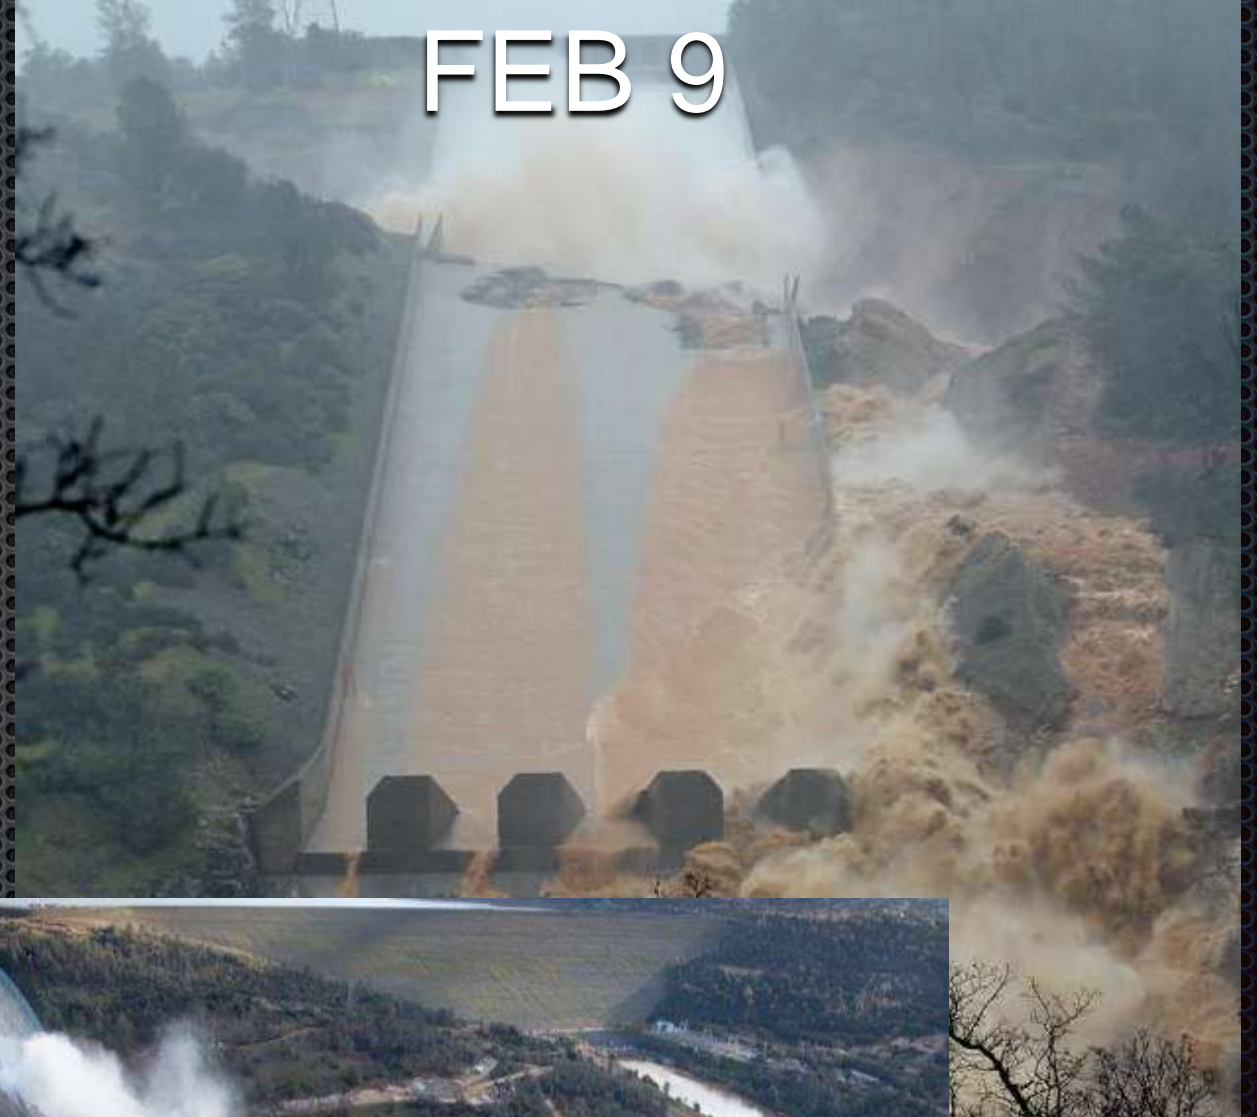
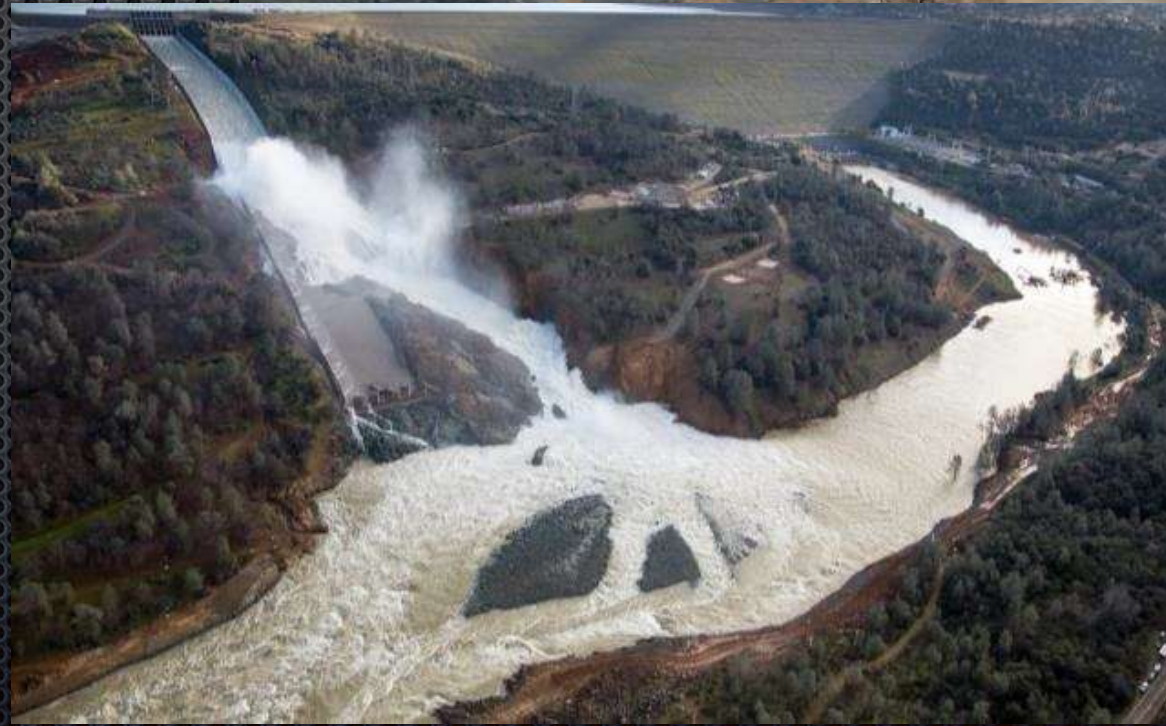
FEB 9

② February 8: DWR begins ongoing consultation with FERC and other dam safety agencies. DWR runs test flows down the damaged spillway, monitoring further erosion, and prepares for possible use of emergency spillway. 24/7 emergency interagency operations centers activate to study and implement response to flood control spillway and related structures, with careful study of weather forecasts.

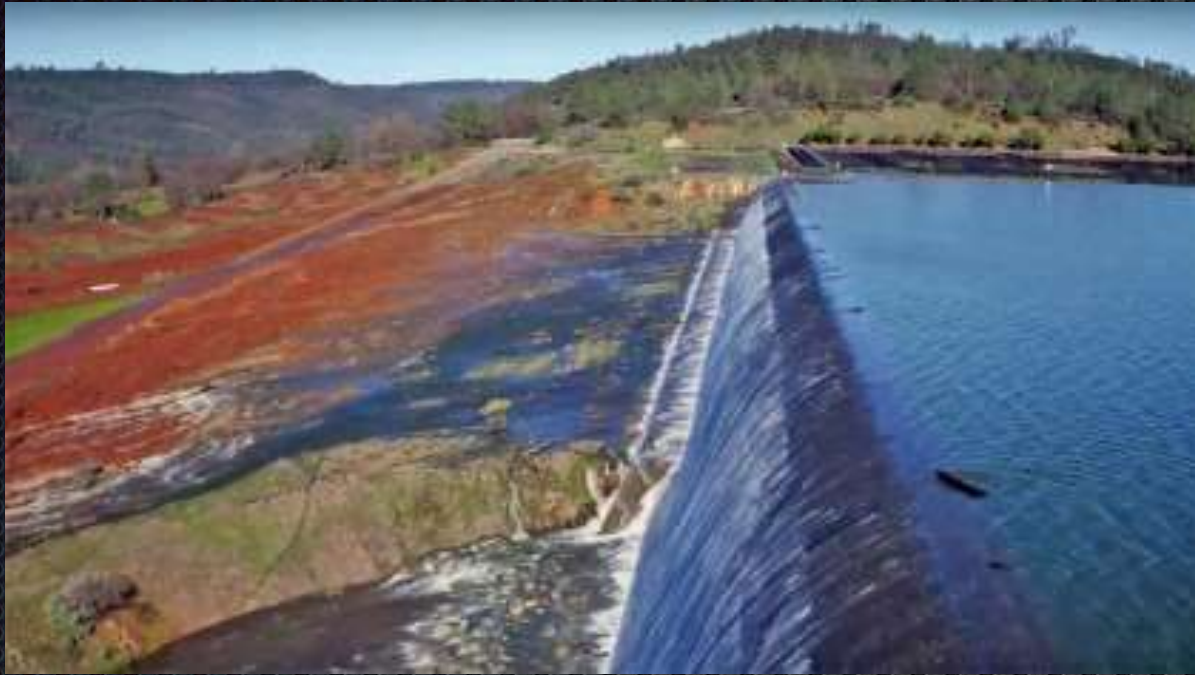
FEB 11

③ February 11: Inflow to Lake Oroville brings lake level above 901 feet. This engages the emergency spillway for the first time in the history of the facility.

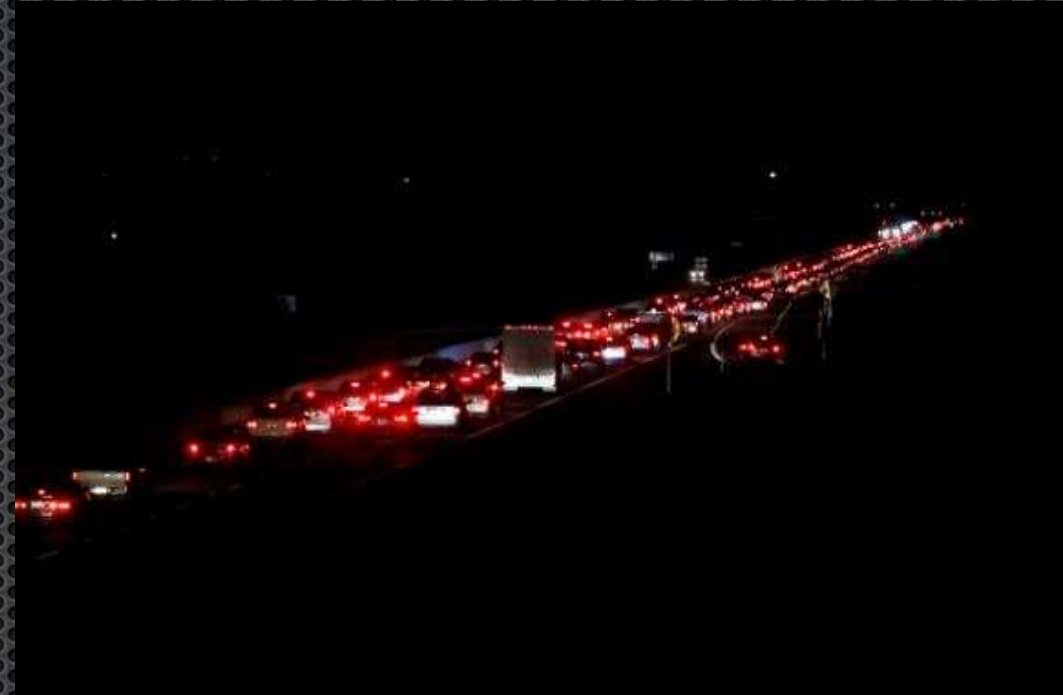
FEB 12

Emergency spillway use begins

④ February 12: Anticipated erosion begins to progress faster than expected at the base of the emergency spillway. The Butte County Sheriff's Office issues mandatory evacuation orders for the Oroville area. To ease pressure on the emergency spillway, the flood control spillway outflow is increased to 100,000 cfs. After several hours, inflows decrease and overflow stops at the emergency spillway. Erosion to the emergency spillway hillside is assessed.

Damage to Emergency Spillway

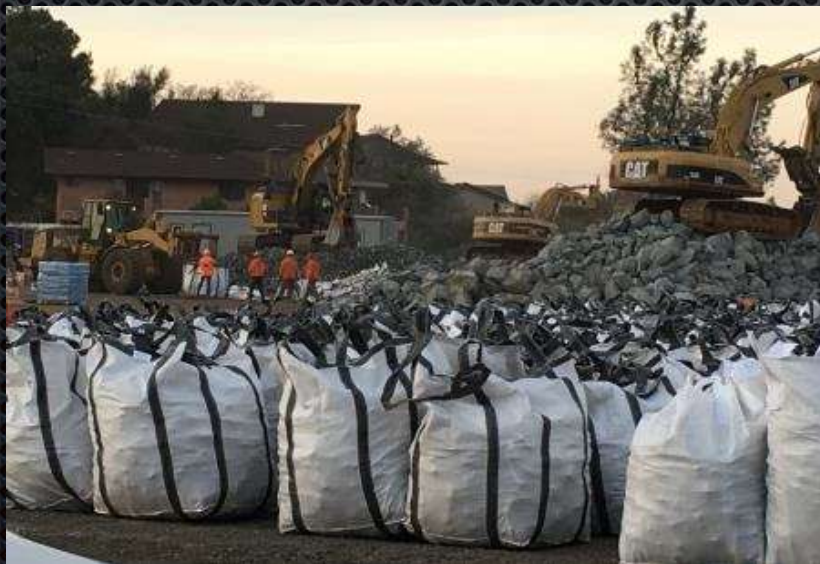
FEB 13

Emergency
repairs
begin

⑤ February 13: DWR crews begin working around the clock to repair the emergency spillway. Evacuation orders remain in effect.

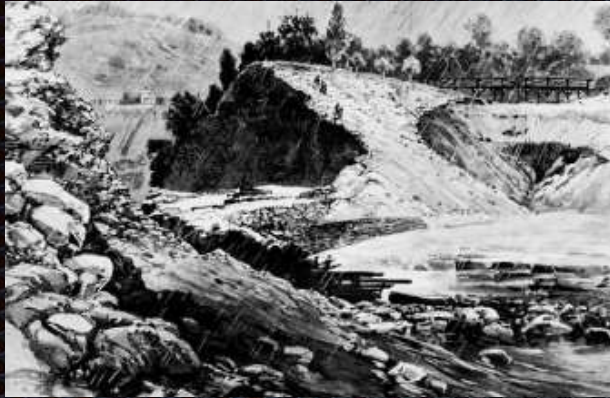
Johnstown, PA May 31, 1889
2,300 killed
Spillway capacity inadequate
Strict liability doctrine spawned

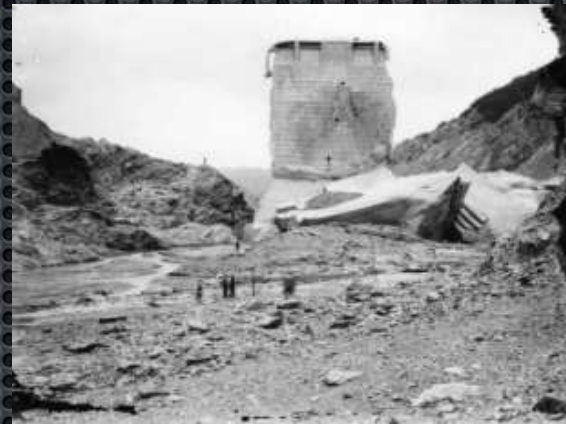
St. Francis Dam, CA March 12, 1928
400-600 killed
Rock abutments flawed
CA dam safety agency DSOD created
Licensing required for civil engineers

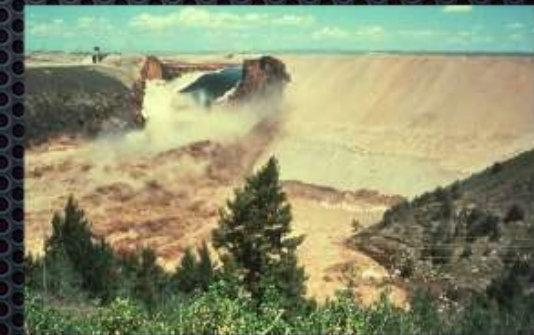
Teton Dam, Idaho
June 5, 1976
11 people killed, \$2B damage
Piping failure
National dam safety program created

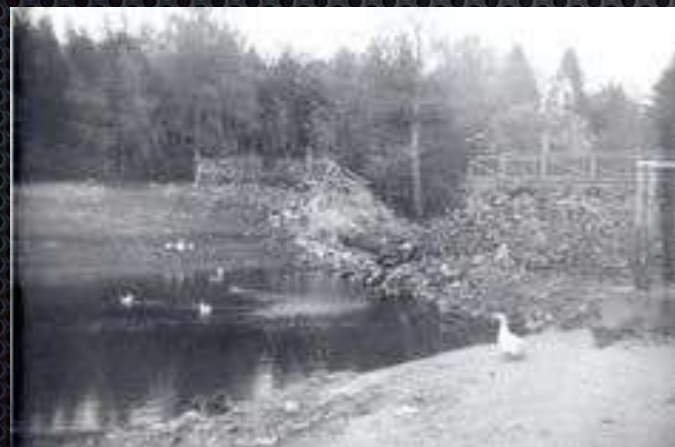
Spaulding Pond Dam,
Norwich CT, March 1963
6 killed, bad design and maintenance

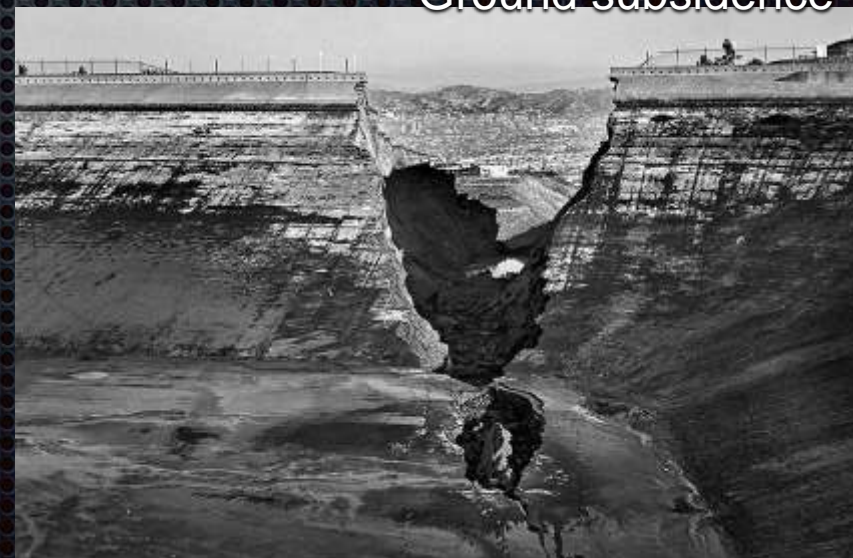
Baldwin Hills Dam, CA
Dec, 1963
5 killed
Ground subsidence

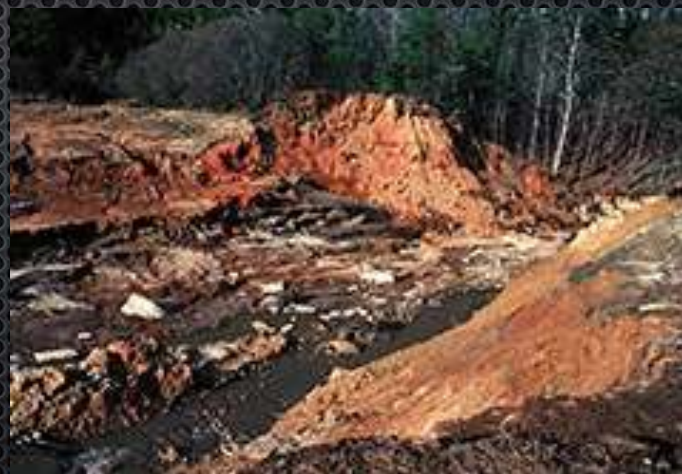
Kelly Barnes Dam,
Georgia 1977
39 killed
Spillway problems, slump on dam face

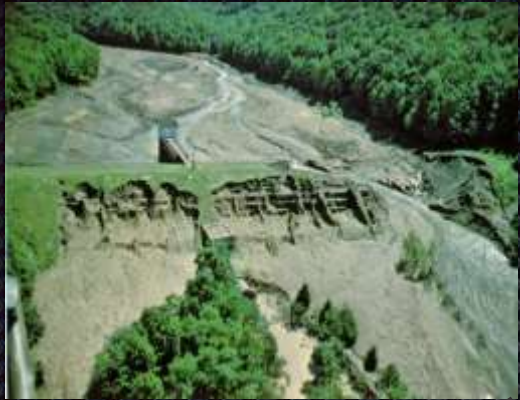
Johnstown PA, 1977
88 killed
Inadequate spillway

“We investigated this dam in the ‘60s. Its deficiencies were recognized and reports prepared for modification, but for various reasons, over a period of one-and-a-half decades, remedial steps or new construction was not taken.

If the dam had been upgraded in accordance with today’s prudent engineering practice, the dam would have been able to store and/or pass the storm.”

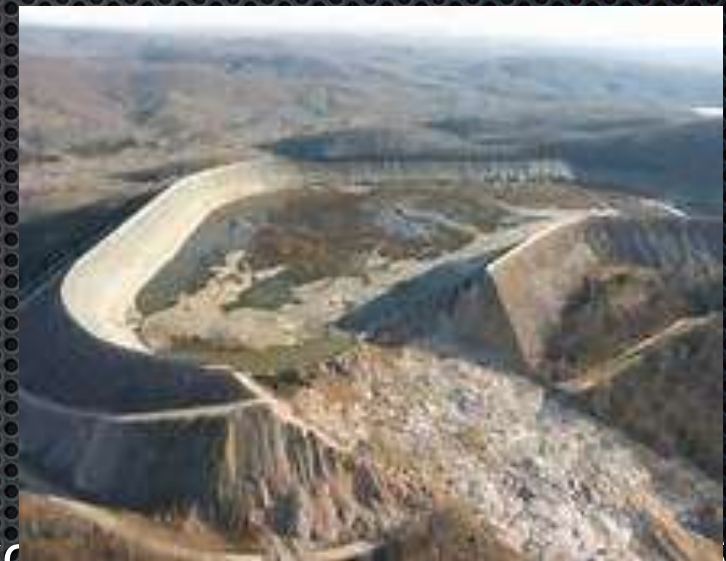
Taum Sauk, 2005
0 killed

Designed with no spillway

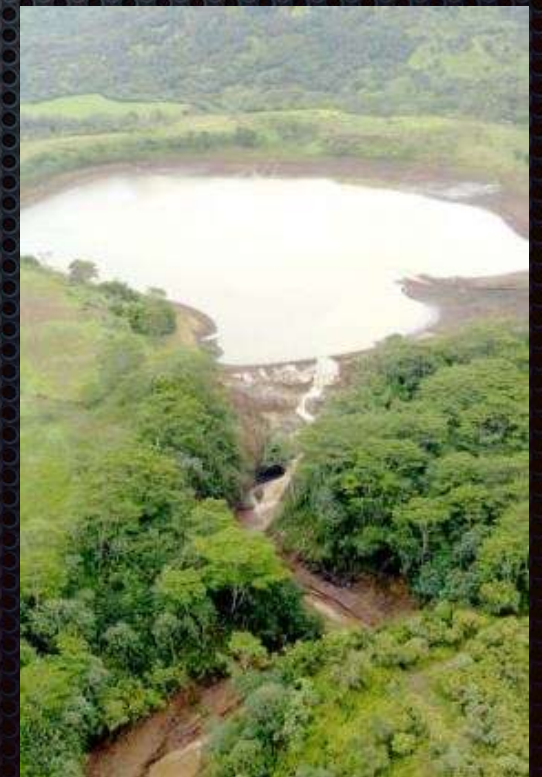
Ka Loko Dam, Hawaii, March 2000
7 killed

Bad maintenance, illegal mods

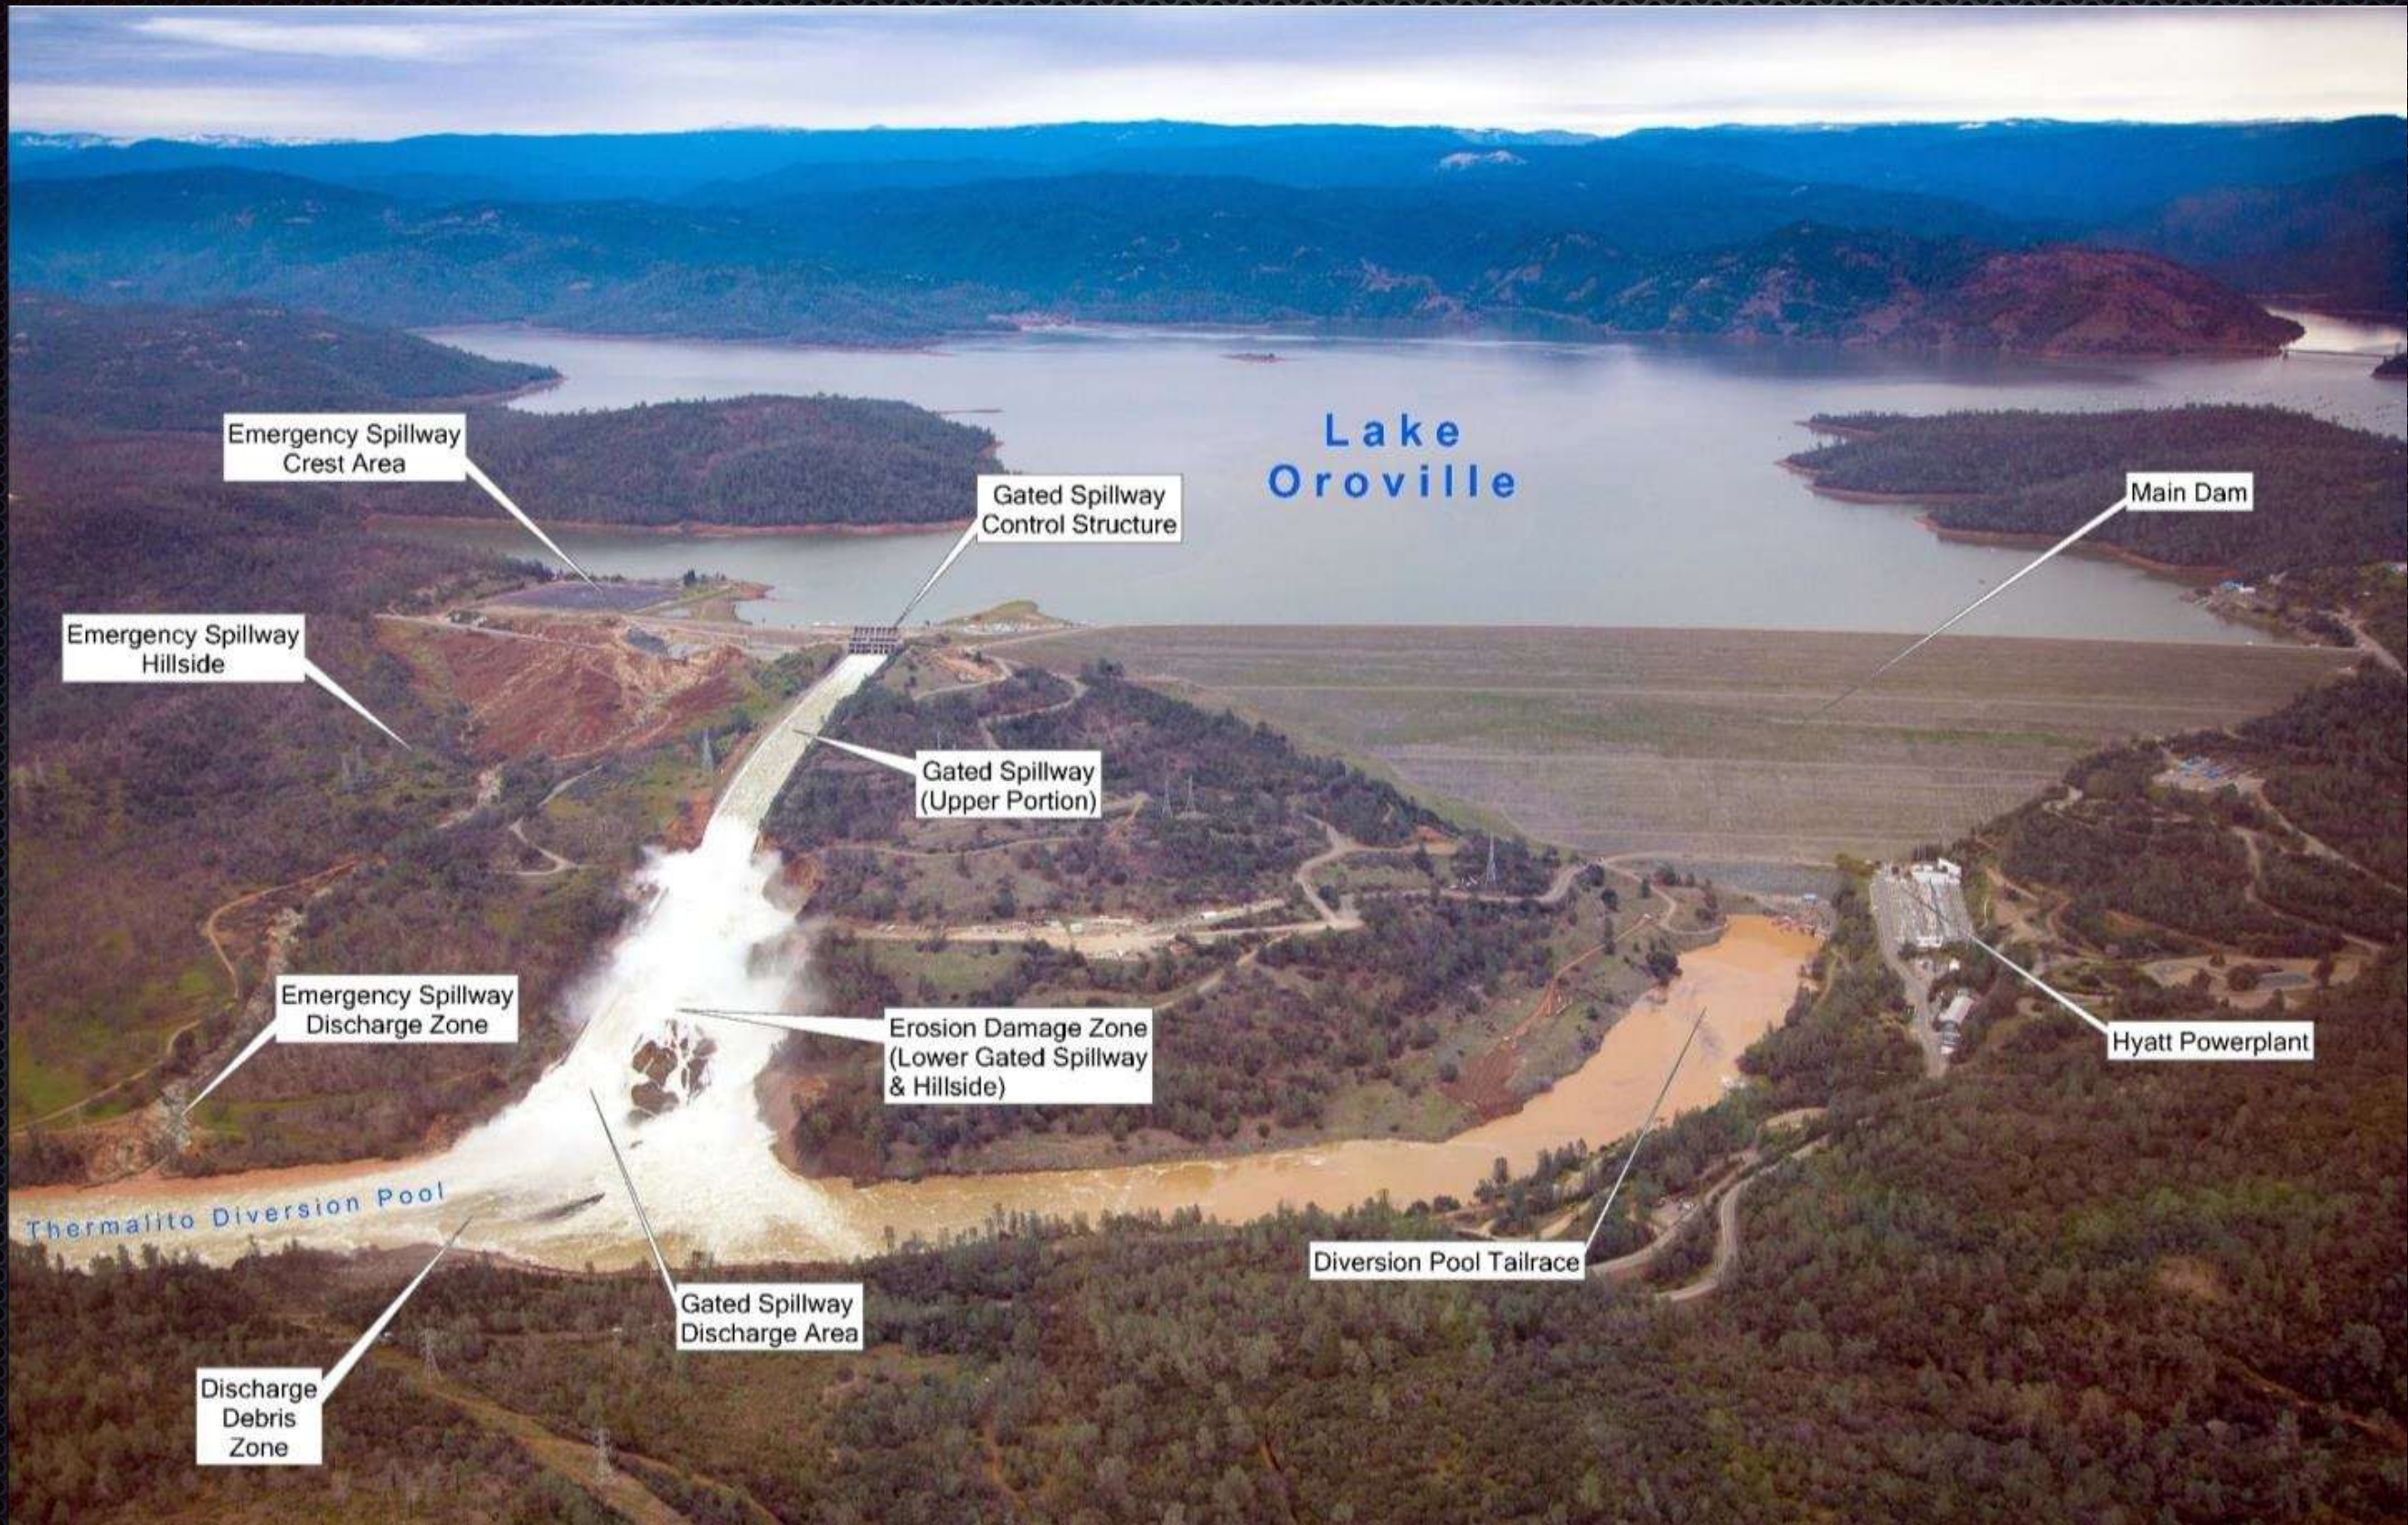
Lake Oroville Facilities

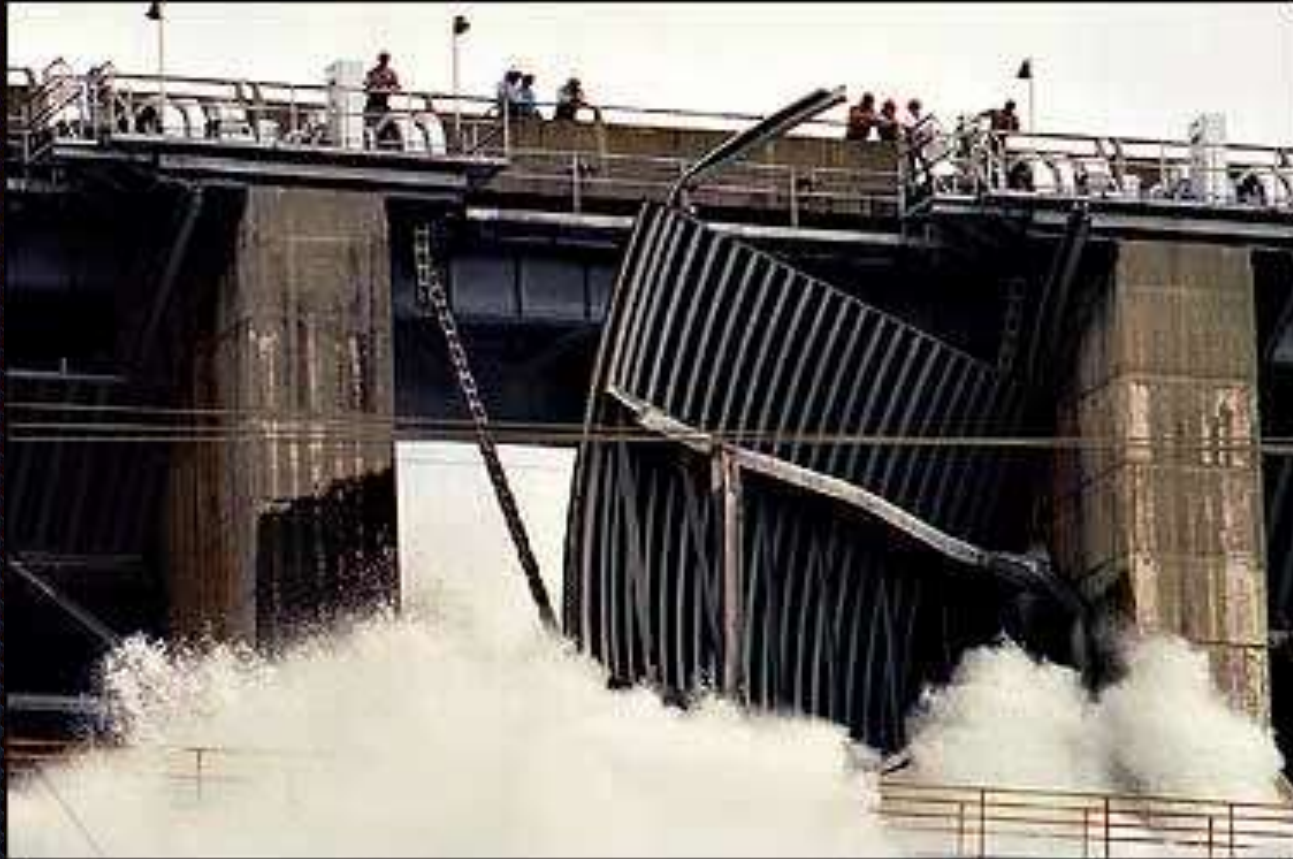
Folsom Dam 1995
Gate failed open.
Reminder that mechanical devices fail.

Erosion issue unforeseen, but gates such as those found on the main spillway can and do fail (e.g. Folsom 1995).

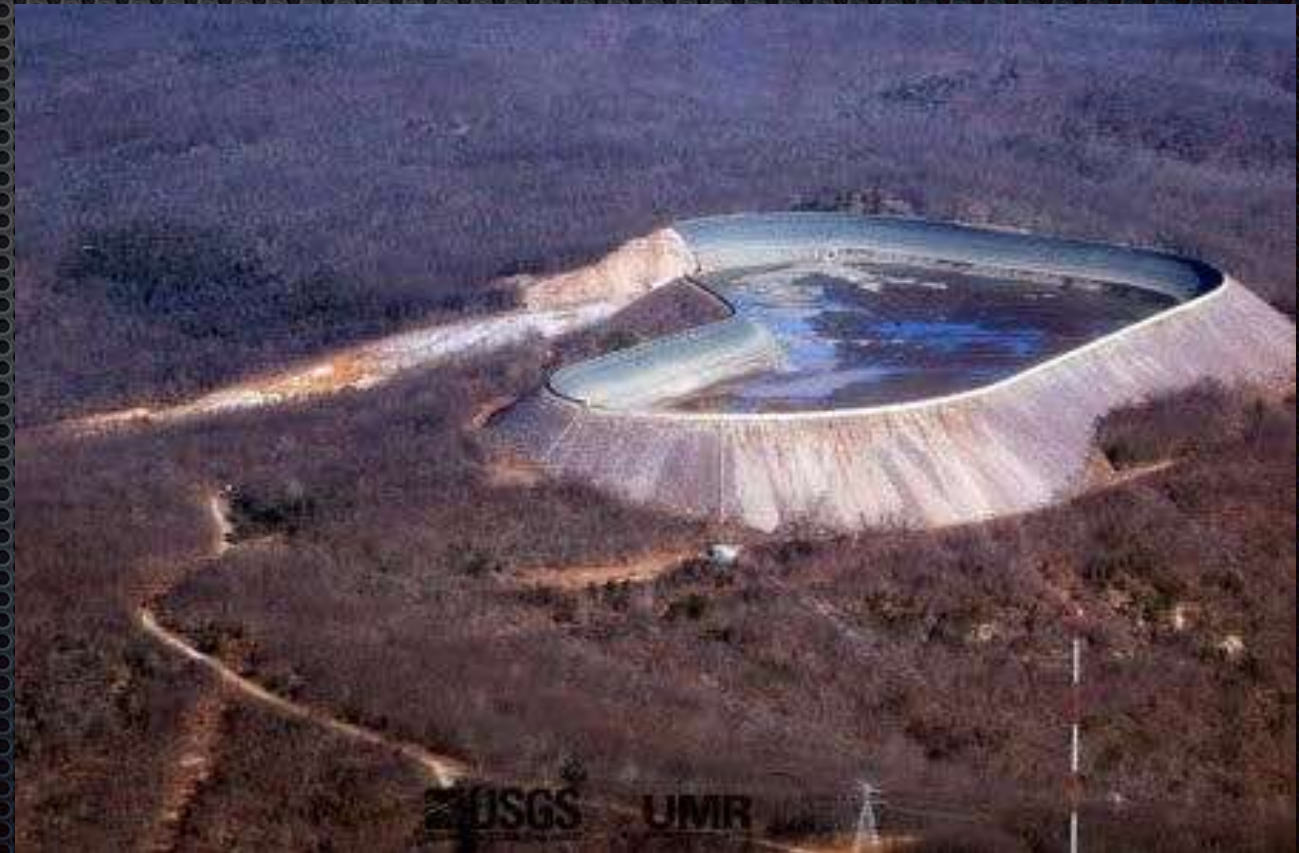
Taum Sauk, 2005
0 killed
Designed with no spillway
